NATIONAL DAM INSPECTION PROGRAM. FORDS LAKE DAM (NDI ID NUMBER --ETC(U)

FORDS LAKE DAM

NDI ID No. PA-00298  
DER ID No. 35-064

PHASE I INSPECTION REPORT  
NATIONAL DAM INSPECTION PROGRAM

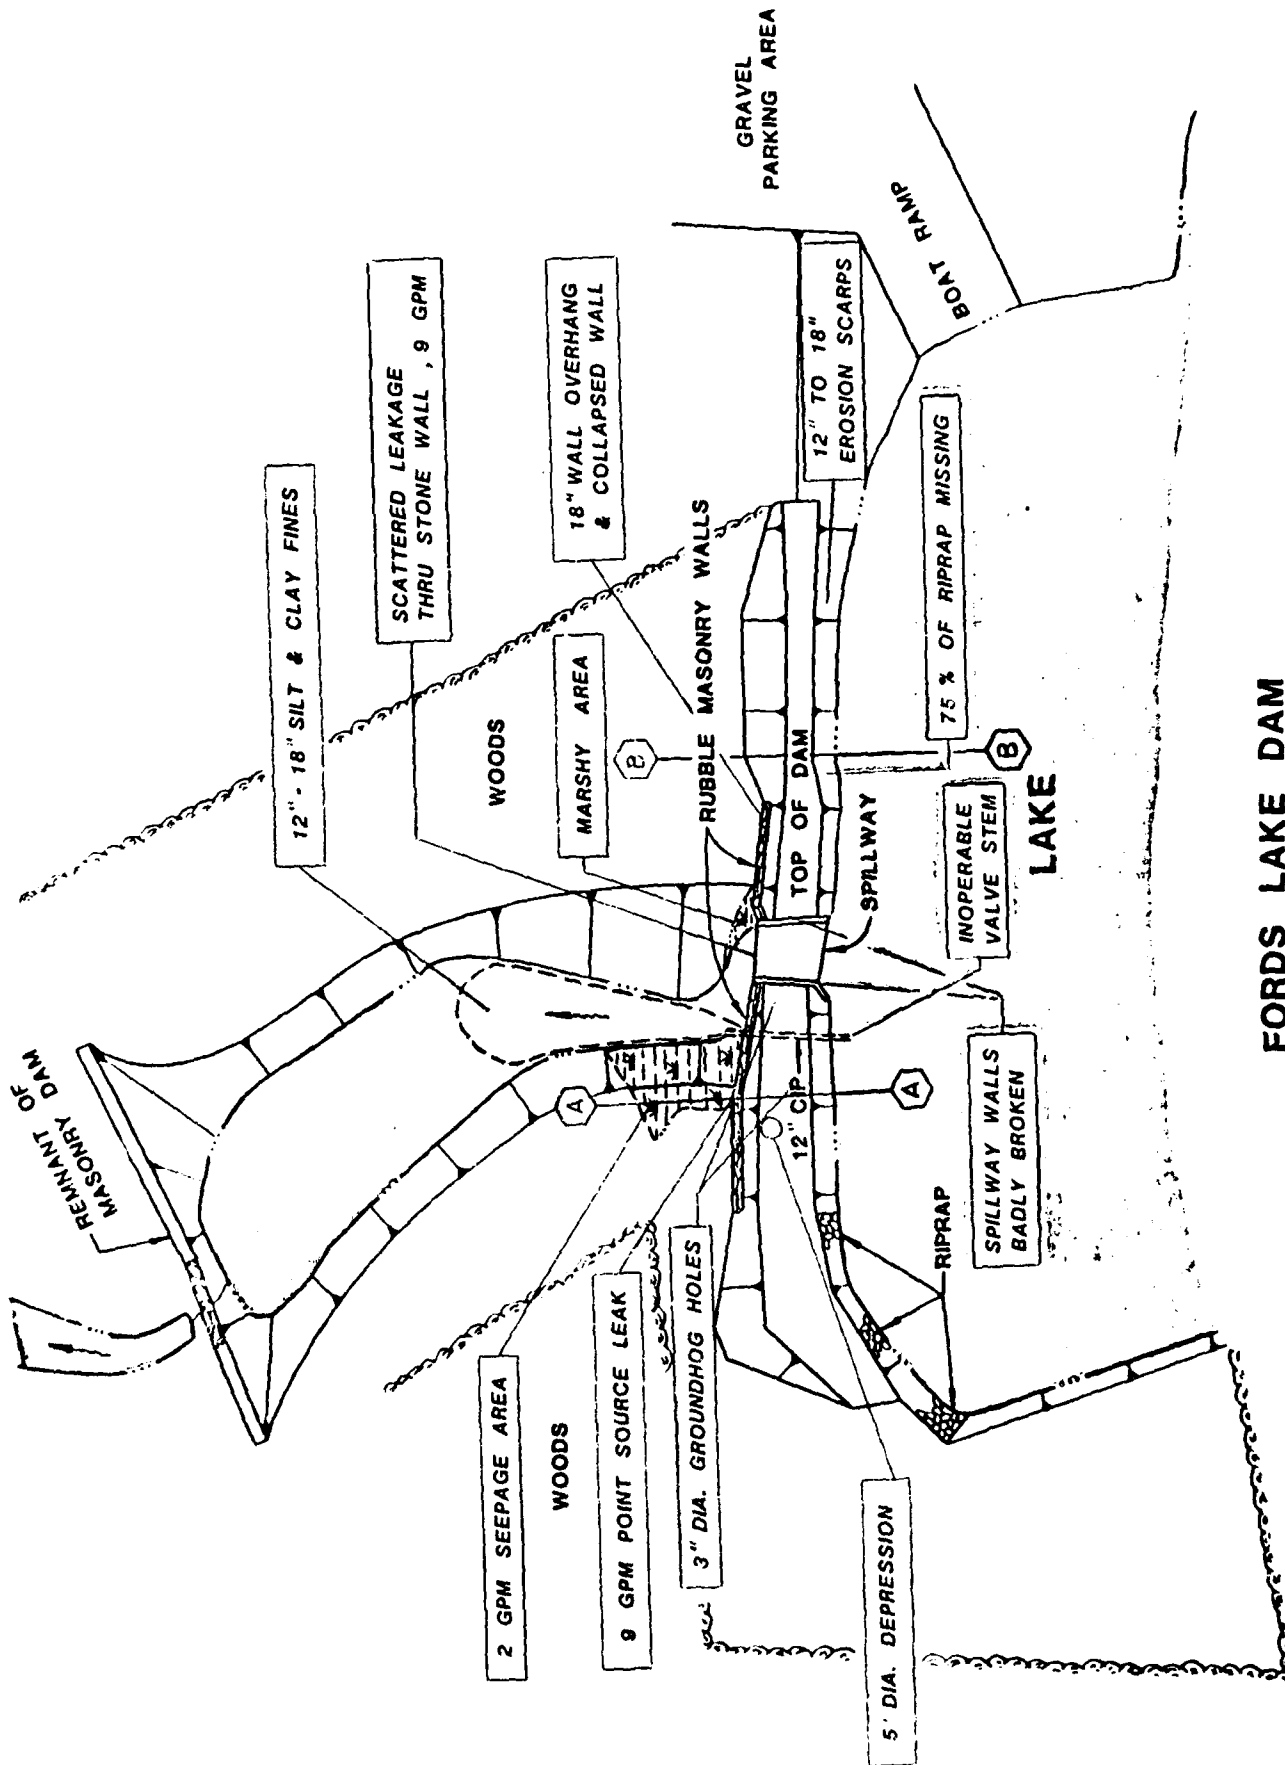
# FORDS LAKE DAM GENERAL PLAN - FIELD INSPECTION NOTES

a. General. The overall appearance of the dam is very poor. Deficiencies observed during the field inspection are illustrated on the General Plan, Exhibit A-1, Appendix A. The profile and typical sections of the dam are presented in Exhibits A-2, A-3, and A-4, and are based on field survey made the day of the inspection. On the inspection date (12/08/80), the lake level was at elevation 1146.8, about 0.2 foot below spillway crest. Pertinent features observed are shown in photographs, presented in Appendix C.

a. Dam. A shallow 5-foot diameter depression on top of the dam is located opposite a point source seepage at the toe of the rubble masonry wall (see Exhibit A-1 and Photograph 7, Appendix C). Although the measured flow on the inspection date was clear, the existence of internal erosion in the upstream earth material by seepage forces could not be ruled out by the observed conditions. Annual backfilling of the depression by the Fish Commission personnel and the observed accumulation of silt and clay directly downstream of the seepage area suggest that internal erosion in the upstream earthfill section of the dam has been in progress for quite some time. If this piping and internal erosion of the embankment remains unchecked, the expected undermining of the rubble masonry section could affect the structural integrity of the dam. A relatively high elevation of seeps, depicted by icicle formation on the downstream face of the dam, was noted. The relatively high elevation of the seepage exit line suggests possible clogging of the voids within the stone by the migration of soil particles from the upstream earthfill section of the dam. The collapsed section of the right wall and the displacement and bulges in the masonry wall suggest instability of the structure.
